# The Ice Particle Threat to Engines in Flight

**This paper discusses jet engine powerloss and damage due to ingestion of ice particles. In the mid-90s several commercial airplane jet engines experienced more frequent powerloss in ice particle conditions, resulting in a focused investigation, and a greater awareness that led to recognition of similar events on other aircraft. Since the mid-90s, events have been more numerous, and costly, and have generated greater industry interest. These events have been predominately associated with flight at high altitude near deep convective systems, often in tropical regions. Data are presented from flight-testing and an event data base to support the contention that the events are caused by ingestion of high concentrations of ice particles, and that supercooled liquid water is either of secondary importance or not required. The basic theory of how ice accretes in the engine by this process is described. Complex issues facing industry to mitigate the problem, and simulation of the ice particle environment are discussed.**

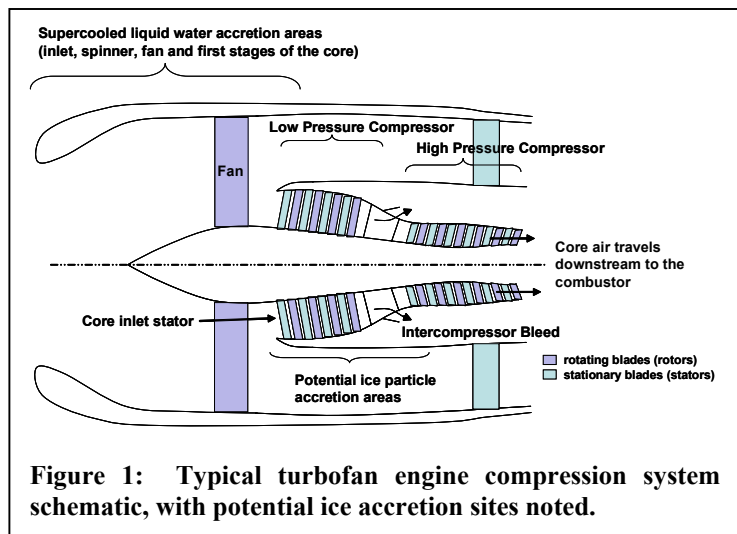
Following considerable research and analysis complemented by flight tests conducted by the airframe and engine manufacturers, the cause of the rollbacks was determined to be the build up of ice on the second stage stator inside the engine core passage (Fig. 1) in ice particle meteorological conditions, and without the presence of significant supercooled liquid water. As the aircraft descended to warmer air at a lower altitude after the event, the ice blockage was released, making the engine recovery process possible. In the case of this specific type of commuter aircraft, results of the investigations have led to successful engine modifications, and events from this commuter aircraft have ceased. The data from one of the flights conducted during this flight test program are described in section IV, and the accretion of ice in the engine is further discussed in section VIIB.

**Figure 1: Typical turbofan engine compression system schematic, with potential ice accretion sites noted.**

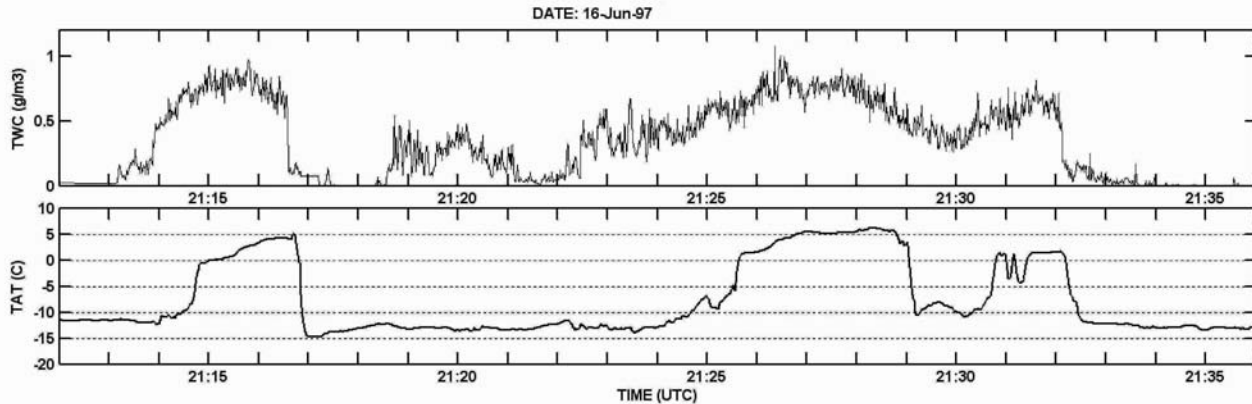
**Figure 6: Time history of TWC (top panel) and Rosemount total air temperature (TAT, bottom panel), showing the TAT ‘anomaly’ caused by ingestion of ice particles, for a portion of the commuter test flight on 16 June 1997.**

The flight test aircraft was equipped with a Rosemount TAT sensor of similar design to those installed on all the aircraft of the event database. Fig. 6 illustrates an example from this project of a TAT anomaly encountered while flying straight and level at an ambient temperature of about  $-26^{\circ}\text{C}$  ( $\text{TAT} \sim -12^{\circ}\text{C}$ ) across a cloud with moderately high IWC. The cloud was determined to contain at most trace amounts of supercooled LWC, because the Rosemount Ice Detector ramp voltage trace was very flat during this entire pass (not shown). Shortly after the estimated IWC (top panel) rose in the first cloud encounter ( $\sim 21:14$  UTC), the TAT (bottom panel) also rose from an undisturbed value of about  $-12^{\circ}\text{C}$  to a plateau value of about  $0^{\circ}\text{C}$ , but then continued to rise to about  $5^{\circ}\text{C}$ . On exit from the high IWC region, the temperature quickly dropped back to approximate pre-cloud values. Similar behavior was observed during a second cloud encounter from 21:22-21:32, although there did not appear to be much TAT effect in a lower IWC cloud between the two high IWC clouds. In fact, for this case, the anomaly appeared to trigger within 60 seconds of the IWC exceeding  $0.5\text{ gm}^{-3}$ , and had cleared within 30 seconds of the IWC dropping below  $0.5\text{ gm}^{-3}$ . Lawson et al. (1998)<sup>1</sup> have discussed the TAT anomaly at length, and have displayed a similar figure illustrating the correlation of temperature change to apparent IWC, and the rapid clearing of the probe after exit from ice particle conditions. They pointed out that a similar TAT experience had been reported by Holland et al. (1984)<sup>9</sup> while flying in a broad convective outflow region of a tropical storm near Australia, and incorrectly interpreted as an intrusion of warm air from the stratosphere. The same misinterpretation of the TAT anomaly as a warm zone was made at the initial stage of this commuter engine event investigation. Lawson et al. (1998)<sup>1</sup> further reported that wind tunnel testing by the probe manufacturer confirmed that it could ice up in super cooled liquid water/ice particle concentrations that could have been encountered during rollback events.

As in Lawson et al. (1998)<sup>1</sup>, in this article we link the TAT anomaly to ingestion of ice particles, presumably which block the airflow through the heated housing, and corrupt the measurement. Further information on the incidence of the TAT anomaly is available from the event database. All the aircraft involved in the 46 engine powerloss cases (both large transport and commuter aircraft) investigated in this report are equipped with a total air temperature (TAT) probe of similar design. The event database contains four engine events in which a TAT anomaly was observed at an outside air temperature below  $-40^{\circ}\text{C}$ , the minimum temperature at which supercooled LWC can occur. Furthermore, of the 35 cases in the event database in which the existence of a TAT anomaly could be determined from available data, in only one of those cases was there a conclusive report of some airframe icing. It is therefore concluded that TAT icing occurs in glaciated cloud, as it did in the case study above, and all but one

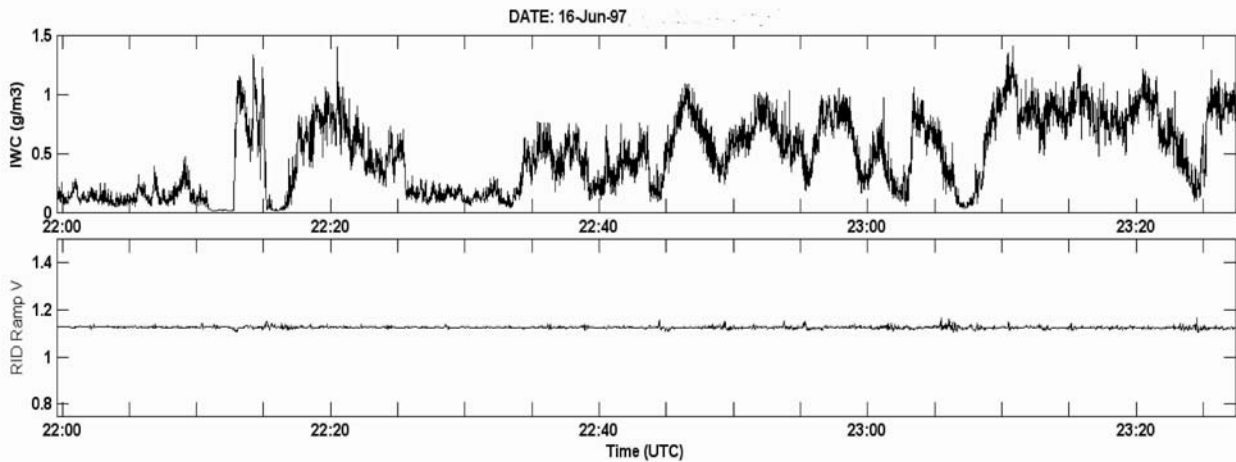
**Figure 7. Time history of estimated TWC (top panel), and Rosemount Ice Detector (RID) Ramp Voltage (lower panel) during an orbit at 8800 m and  $-28$  C downwind of an isolated cumulonimbus cloud. An engine rollback process was completed between 23:13-23:28.**

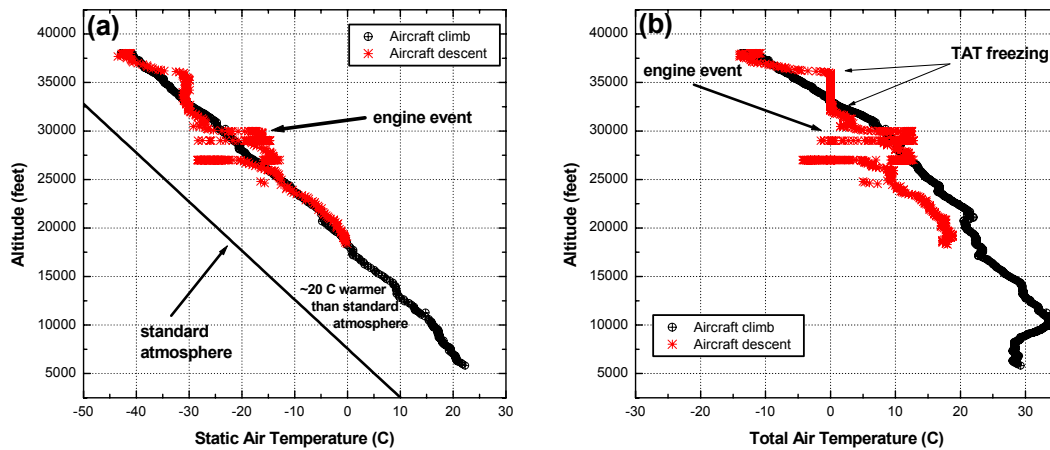
Below 32,000', the TAT is erratic, with perturbations towards warmer temperatures until about 26,000', after

**Figure 10: Static air Temperature (a) and Total Air Temperature (b) measured during climb from Hong Kong (black symbols) and during descent towards Taipei (red symbols), illustrating the TAT anomaly observed before the engine event**

which point it resumes normal behavior. Based on the correlation between TAT and IWC observed in Fig. 6, it is therefore surmised that the aircraft entered a region of high IWC at about 37,000' (~ -40°C) that continued to at least 32,000' (~ -28°C). The timing of the event can be observed in Fig. 11. The TAT anomaly commences shortly after 12:46, and continues until at least 12:50. The engine powerloss occurs at 12:52:58, or about 7 minutes after entering the region of presumed high IWC. It is uncertain what can be inferred from the continued peculiar TAT behavior after the engine event. The elevated readings between 12:51 and 13:01, implying significantly higher than the expected SAT values, may be some unknown clearing behavior of the probe as the TAT goes above 0°C. It is therefore impossible to speculate in this case on whether further high IWC regions were encountered during this later period. However, a second characteristic region of TAT pegging to 0 C is observed at 27,000' and -22°C from approximately 13:01:30 – 13:03:30, and shortly thereafter the temperature probe clears and provides SAT values similar to the climb profile.

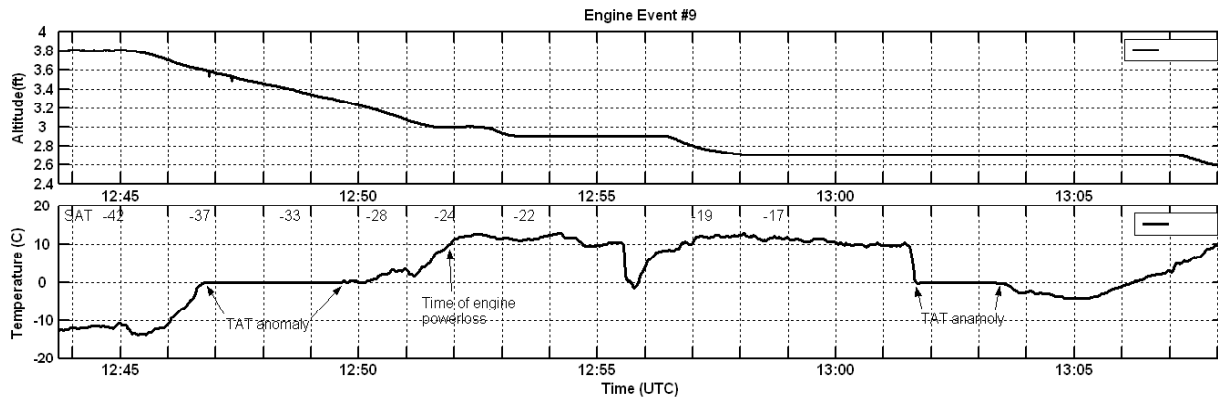
**Figure 11: Time history of altitude and Total Air Temperature (TAT), surrounding the time of the engine event at 12:52:58. The estimated Static Air Temperatures (SAT) are shown in text at the top of the lower panel for reference. Note the time of powerloss is identified in figure.**

The crew reported a multiple engine shutdown at 30,000' (~12:52:58 UTC). The multiple engine failure checklist was immediately performed, and the engines recovered to idle within 75 seconds. The aircraft was flown without further incident to its intended landing in Taipei approximately 20 minutes later.

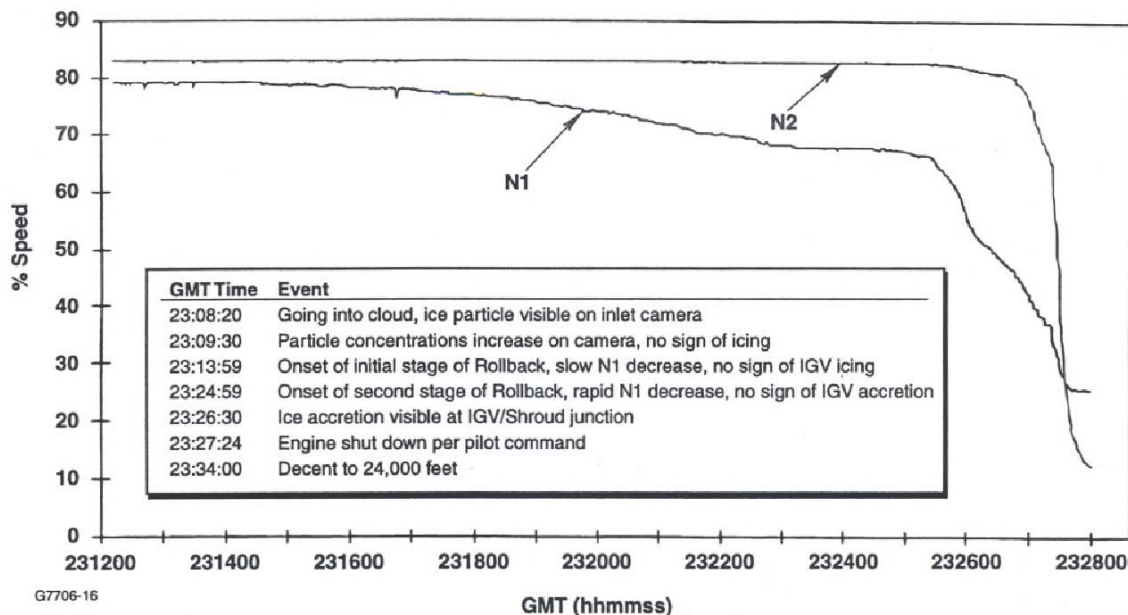
Test results on the rollback engine clearly showed that all engine parts visible on the inlet camera were free of ice during the initial slow speed decay stage of the rollback event. These included the fan spinner, a rotating fan rotor and the first stage compressor stator vanes at the engine core passage inlet. Ice formation on the core inlet vanes was visible after the engine rollback occurred, because the engine core and fan speeds had significantly reduced and could no longer support the energy requirement of the inlet anti-ice system. A correlation of the cloud microphysical data, and the engine data plotted in Fig. 12, showed that the onset of the initial rollback stage took place 5 minutes and 40 seconds after cloud entry. The flight test rollback scenario was similar to all the recorded

**Figure 12: Engine data from the rollback test flight described in section IV, with text description of the cloud and engine observations. N1 and N2 are the fan and core speed respectively**

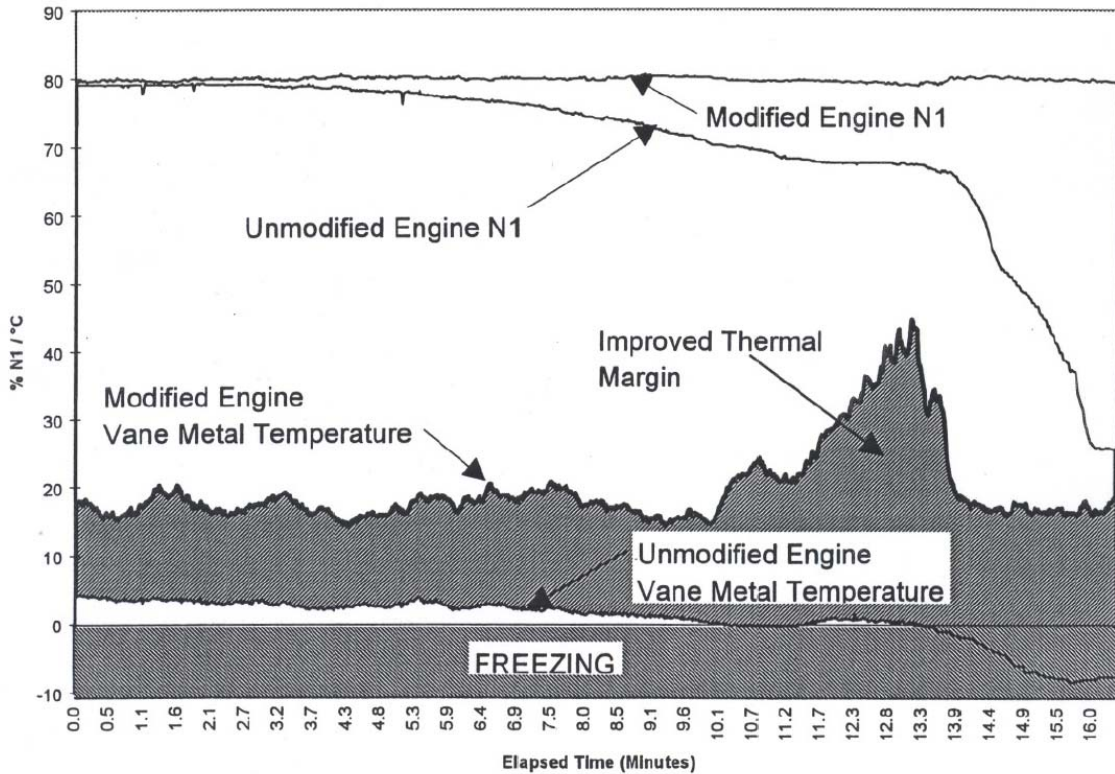
**Figure 13: Modified and unmodified engine vane metal temperature for the period as Fig. 12. Elapsed time is from 23:12:00 UTC.**

field events in that the engine remained on a slow decay stage for seven minutes before the onset of a rapid decay stage. The test data supports the theory that icing blockage of the flow path behind the first compressor stator vanes was the root cause of the engine incidents. Thermocouple data, shown in Fig. 13, recorded on stator vanes further downstream of the core inlet also supported this theory. The data taken on the unmodified (build-of-material) compressor second stage stator vanes, also known as exit guide vanes (EGV), indicated a rapid surface metal temperature reduction soon after entry into the cloud. The temperature hovered around the freezing point (within instrumentation errors) until the onset of the rapid decay stage of the rollback. This period of freezing point measurements was an indication that ice was accreting continuously on the EGV surfaces. This temperature data indicated that ice started to accrete on the EGV surfaces soon after cloud entry, creating blockage and initiating the slow decay stage of the rollback. Ice continued to build and pressure loss increased until the final rapid decay stage of the rollback was reached. In the rapid decay stage, the local air temperature dropped below freezing. In this stage, due to the rollback rotor speeds, the fan and compressor could no longer increase the local air temperature and therefore the entire front section of the engine was bathed in cold ambient air, as reflected in the metal temperature measurements. The ice accreted on the EGV and the metal temperatures underneath the ice followed this temperature trend.

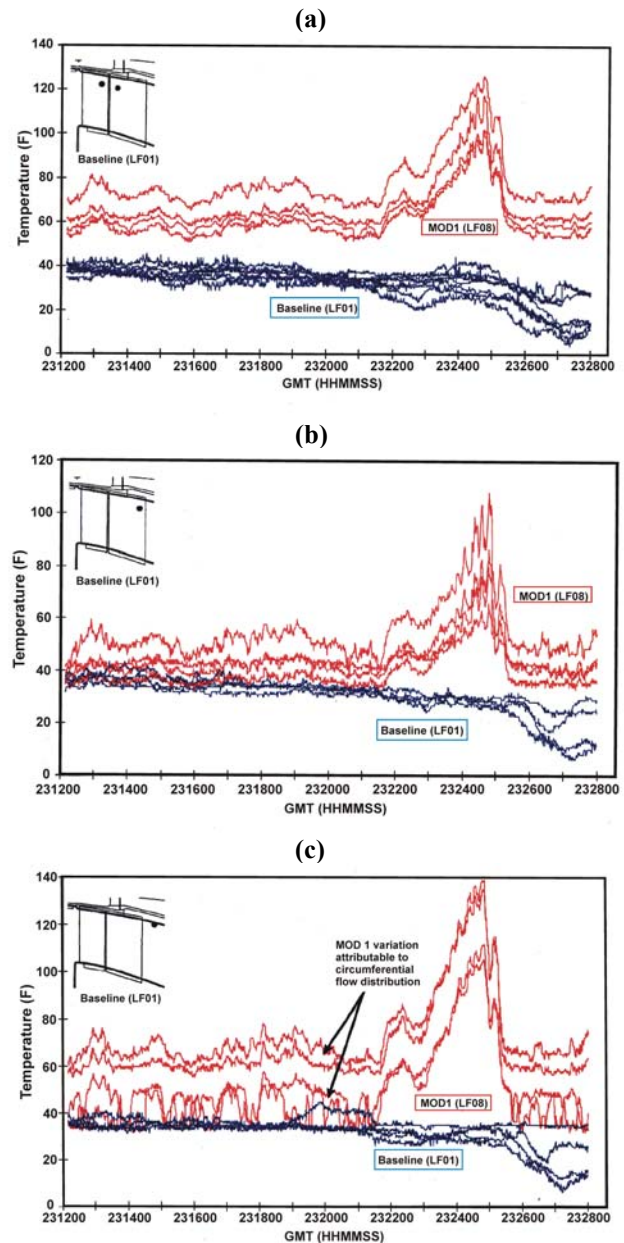
This engine utilized a unique dual-airfoil EGV design as shown in Fig. 14. During the initial investigation of the rollback events, it was suspected that ice was accreting at the junction of the front vane trailing edge and the aft vane leading edge only. However, since freezing point temperature measurements were recorded in many locations on the EGV which included the junction point (Fig.14a blue curve), the trailing edge of the aft vane (Fig.14b blue curve), and the flow path shroud wall immediately behind the EGV (Fig.14c blue curve), these data dismissed the speculation that the dual-airfoil vane was the primary reason for ice blockage. It was concluded that any unheated airfoil located at the EGV location with similar turning characteristics would produce ice accretion and the associated flow blockage.

**Figures 14 a-c: Thermocouple temperatures on the Exit Guide Vanes of the modified (MOD1) and unmodified (Baseline) engines during the rollback flight test described in section IV. Inset geometry shows location of thermocouple for each figure**

The modified engine hardware incorporated an anti-ice heat supply within the EGV. Its metal temperatures remained above freezing during the entire flight test, indicating ice-free metal surfaces throughout (Figs.14a-14c, red

curves). Further analysis indicated that the heat provided was sufficient to maintain ice-free surfaces for the glaciated/mixed phase icing envelope identified for this series of engine incidents.
