# The Ice Particle Threat to Engines in Flight

**This paper discusses jet engine powerloss and damage due to ingestion of ice particles. In the mid-90s several commercial airplane jet engines experienced more frequent powerloss in ice particle conditions, resulting in a focused investigation, and a greater awareness that led to recognition of similar events on other aircraft. Since the mid-90s, events have been more numerous, and costly, and have generated greater industry interest. These events have been predominately associated with flight at high altitude near deep convective systems, often in tropical regions. Data are presented from flight-testing and an event data base to support the contention that the events are caused by ingestion of high concentrations of ice particles, and that supercooled liquid water is either of secondary importance or not required. The basic theory of how ice accretes in the engine by this process is described. Complex issues facing industry to mitigate the problem, and simulation of the ice particle environment are discussed.**

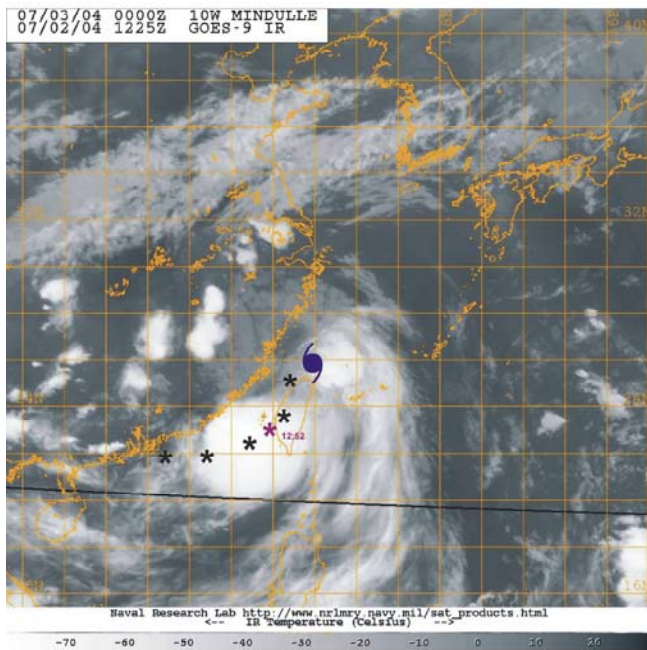
This case study provides a detailed description of a large transport engine event, and a more detailed discussion of some of the common observations noted during events that are summarized in section II. This particular event has been chosen due to its comprehensive in-flight, pilot report, and supporting meteorological data. The event occurred in the early summer on a flight between Hong Kong and Taipei. Category 4 Typhoon Mindulle had tracked from the south/southeast along the east coast of Taiwan, and at the time of the event its had been downgraded to a tropical storm, with a center located about 400 km to the northeast of the aircraft location. During the 5-hour period prior to the event, an area of intense multi-cell convection well to the southwest of the tropical storm center had built up over the South China Sea, and its rapidly expanding anvil area was visible in sequences of satellite imagery. Fig. 8 displays the satellite imagery about 30 minutes prior to the incident. The track of the aircraft is depicted as asterisk symbols at 15-minute intervals proceeding east to Taipei. A purple asterisk symbol marks the location of the event. The center of the storm is denoted with the special tropical storm symbol. Note that the incident occurred near the center of a circular bright cloud top anvil region, and was obviously in the vicinity of deep convection. The satellite picture one hour later looks similar, with some growth of the circular area but very little translation, and it is quite clear that the aircraft traversed through the center of this region. Composite imagery from ground meteorological radars over a smaller region encompassing the main cloud traversed by the aircraft is shown in Fig. 9, with open flight-track symbols at 15-minute intervals, and a asterisk denoting the engine event

**Figure 8: Satellite picture of tropical storm Mindulle, with flight track of aircraft across an area of convection in the south China Sea. Black symbols represent the track at 15-minute intervals. The Purple symbol denotes the location of the engine event. The center of the storm is indicated as the special symbol just north of the island of Taiwan.**

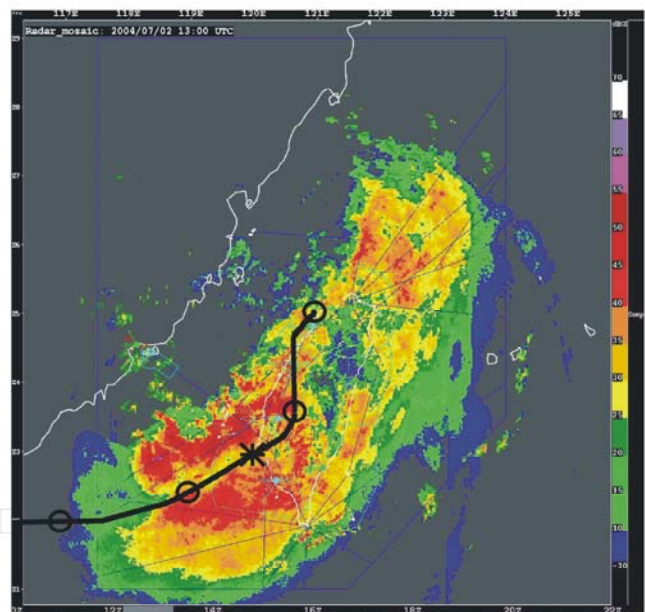
**Figure 9: Composite meteorological radar low-level mosaic for tropical storm Mindulle, approximately 8 minutes after the engine incident. The flight track of the aircraft is shown in the solid line. Fifteen-minute time intervals are marked by open circles, and the position of the engine event is shown by the asterisk.**

position. Note that this is a low-altitude radar reflectivity pattern from surface-based radars, and is thus mapping the pattern of rain and/or possibly unmelted hail regions well below the freezing level, and not at flight altitude. As the aircraft entered the region of precipitation at 38,000' and  $-42^{\circ}\text{C}$  SAT, it was flanking a region of intense low-altitude precipitation to the southeast, with a second intense region to the northwest. The pilot started a descent at about 12:45 (the symbol before the event asterisk on Fig. 9) just on the edge of an area of intense low-altitude radar echoes, and reported entering cloud, heavy rain, moderate turbulence, with some lightning in the general area, but noted no significant radar echoes on his radar and confirmed that there was no airframe icing. Figs. 10a and 10b show the SAT and TAT traces on the climb out of Hong Kong, and during this descent towards Taipei. First note that the SAT temperature profile is about  $20^{\circ}\text{C}$  warmer than a standard atmosphere, an observation similar to that of many engine events. The SAT climb trace is quite similar to that of the descent, except between 37,000' and 26,000', where the descent temperature-trace is peculiar. Overall, referring to the TAT profiles, the beginning of a TAT anomaly is apparent on the descent profile starting at about 37,000' as it pegs and holds at about  $0^{\circ}\text{C}$  until about 32,000', where the expected true TAT (roughly approximated from the climb TAT) goes above  $0^{\circ}\text{C}$ .

altitude, the reflectivity was approximately 16 dBZ, with occasional brief regions of 20 dBZ. Far below and below the freezing level in the heavy rain area of the hurricane, the reflectivity in the bright band exceeded 30 dBZ, similar to the low-altitude reflectivities of Fig. 9, and in fact was attenuated by the heavy precipitation so that actual values are underestimated. A standard pilot's weather radar has a threshold of about 20 dBZ, and would therefore be insensitive to such glaciated high-IWC regions, or would at most show some returns at the green level. One important note is that regions of low-altitude high reflectivity on ground meteorological weather radars in convective storms, such as shown in Fig. 9, are also an indication of potentially high IWC above the freezing level that may be conducive to engine powerloss.
